# GETTING IT RIGHT

*Porcelain Bond Failure Defects by James (The Tile Shop)*

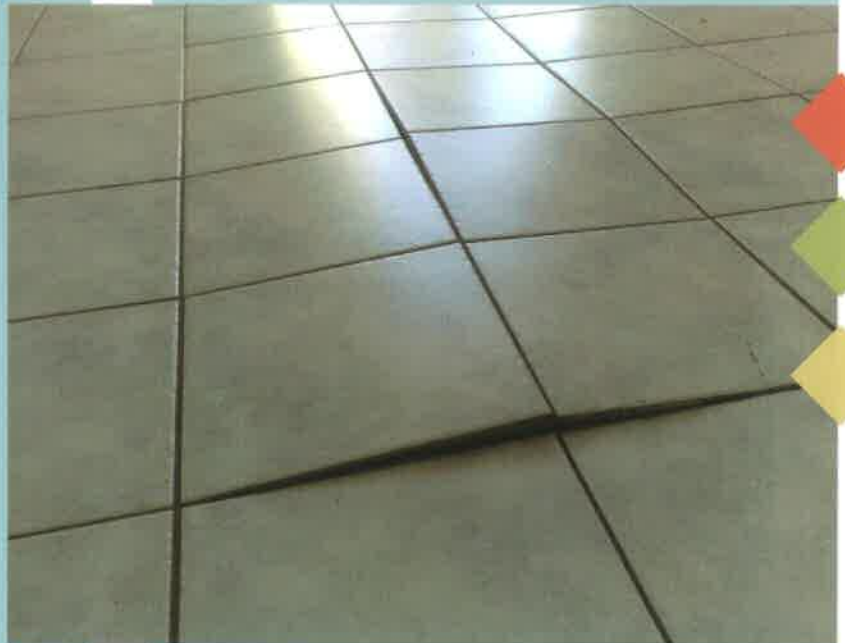
The above photo shows peaked or pyramided tiles.

Yes, this is still a common occurrence, this is not just associated with Australian made tiles from 20 years ago. This particular failure occurred well within builder warranty period. In Townsville alone, one T.R.I.M contractor reported, at the height of summer this year, he would sometimes attend up to 3 peaked failures in a given week.

Most comments made by parties concerned at seeing this kind of failure is that 'the tiles have grown'. It is more proven that concrete substrate shrinkage is a natural occurrence, than tiles excessively expanding.

Only through complete compliance - with Australian standards/ guide to installation of ceramic tiles - and in accordance with adhesive manufacturers recommendations, can these types of failures be minimised,
