FLOODED TILES DON'T ALWAYS NEED DEMOLITION

Flooding over floor tiles presents a number of unexpected influences acting on the tiling system, over and above what would be considered normal building service conditions, writes **Andrew Golle**.

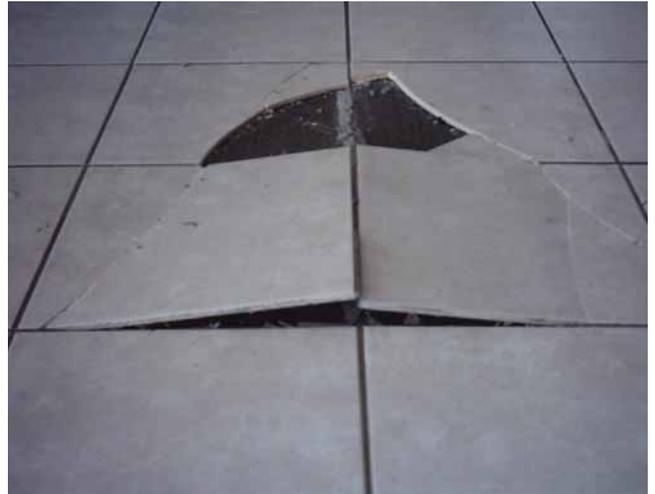
Tiles peaked floor.

1. Ineffective movement joints may result in cracked grouting or bond failure. Intermediate movement joints isolate tiled areas into separate bays, allowing for differential substrate movements and shearing action experienced throughout the life of the tiling system. Bays that are not isolated with compressible jointing will apply stress on surrounding tiles, compounding differential movement stress throughout the floor. This may place the adhesives under shear stress over and above expected parameters, especially when exposed to the shock cyclic movement experienced through saturation and then forced rapid drying.

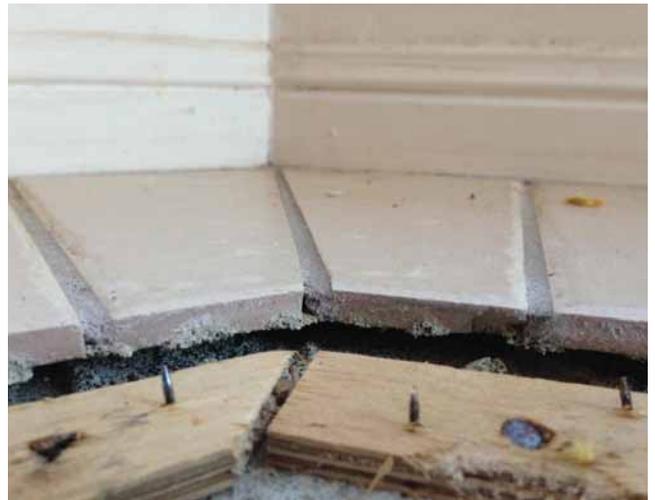
Tiling pinned skirting.

Consideration should also be given to pressure build up and sudden release upon removal of fittings, skirtings and wall linings. Often tiling systems are pinned down by such

elements, and sudden removal may shock tiling from its bonded state to the substrate.

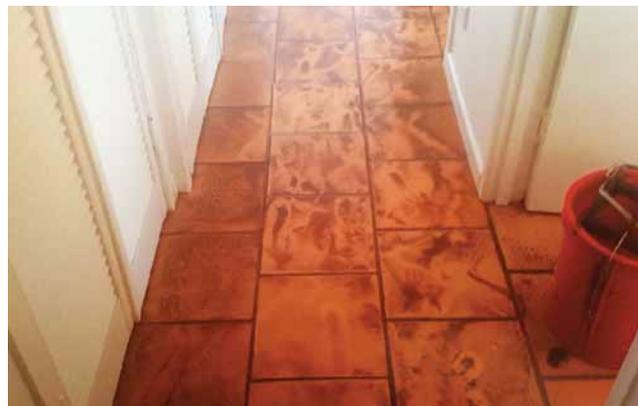
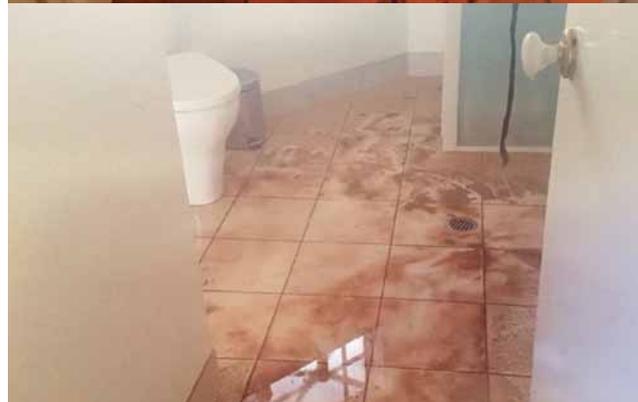
Tile sludge floor .

Sludge inundation over tiles does not automatically indicate that sludge contamination will be beneath the tiles. Tiling that is bonded and sound, at the time of 'sludging' will act as a sand filter. Mud, or 'water based dirt' will leave sludge contaminants on the surface of the tiles, as water permeates the porous tiling system through capillary action and hydrostatic pressure. Any sludge contamination beneath tiles would indicate that the tiles were already loose prior to the flooding event, allowing solids to flow and fill in available cavities under the tiles.

- Sludge residue beneath debonded tiles will indicate that the tiles were already debonded prior to the flooding event.
 - Suspected tiles can be investigated by drilling through the grout joint adjacent to the drummy tile. The drill tailings should be observed.

- Any sludge residue would indicate defective tiles prior to the event.
 - Clean grout residue would indicate bond failure as a result of the event
 - Wet or damp grout tailings do not indicate a defect as yet, and the area should be allowed to dry before retesting for bond failure.

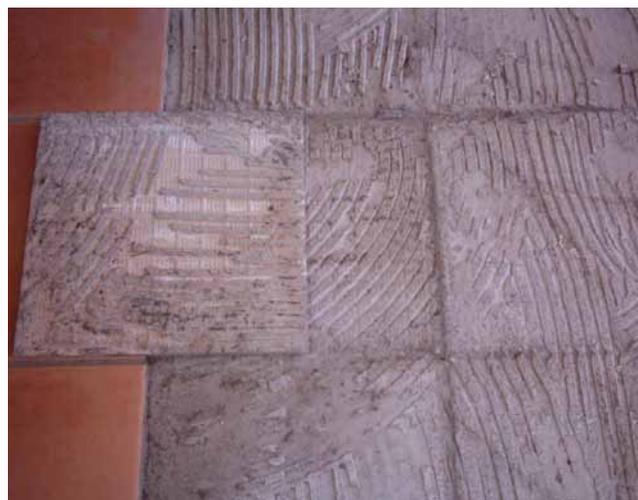
Tiles adhesive shear.

adhesives require a final adhesive thickness of 3-5mm. This is achieved by selecting the correct sized notched trowel, back buttering of the tile and allowing for inconsistencies in substrates and tiles. Most S1 and S2 adhesives rely on polymer modification within cement-based paste, some containing fillers. Up to 5mm of shear tolerance for S1 adhesives, and above 5mm for S2 adhesives is expected where the correct glue thickness is achieved. *You will notice that I am referring to shear tolerance and not flexibility.* The bed thickness becomes critical where deformations to the expected ranges are catered for. Minimal adhesive bed thicknesses result in broken bonds where the shear tolerance doesn't even reach 1 to 2mm.
