# BEWARE THE SOUND OF DRUMS

TILING INSTALLATION DEFECTS CAN SERIOUSLY DETRACT FROM THE OVERALL FINISH OF A JOB AND RESULT IN EXTENSIVE, PAINFUL RECTIFICATION COSTS FOR BUILDERS. IF YOU'RE CHALLENGING A TILER OVER A SUB-STANDARD JOB, THIS ARTICLE WILL ARM YOU WITH SOME SOUND KNOWLEDGE TO HELP YOUR CAUSE.

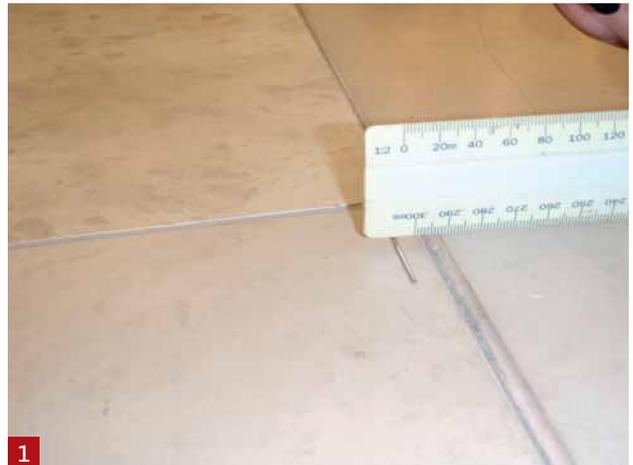
**IMAGE 1:** Lippage between floor tiles. **IMAGE 2:** Cleaning adhesive from movement joints.

Lippage isn't a word you'll find in any English dictionary, but has made its way into AS 3958.1-2007. Lippage is where a vertical lip protrudes between two adjoining tiles. The Standard allowances are:

- cushioned edge tiles > 3mm joint - 2mm lippage;
- rectified edge, > 3mm joint - 1.5mm lippage; and
- rectified edge, < 3mm - 1mm lippage

Lippage between rectified edge tiles appears more severe than it does between cushioned edge tiles, and it may constitute a trip hazard in floor tiling. Rectification ➤

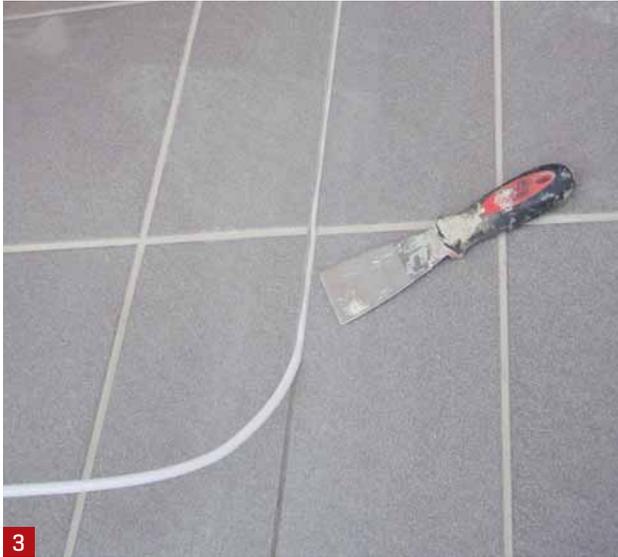
**IMAGE 3:** Installing backing rod to movement joints.

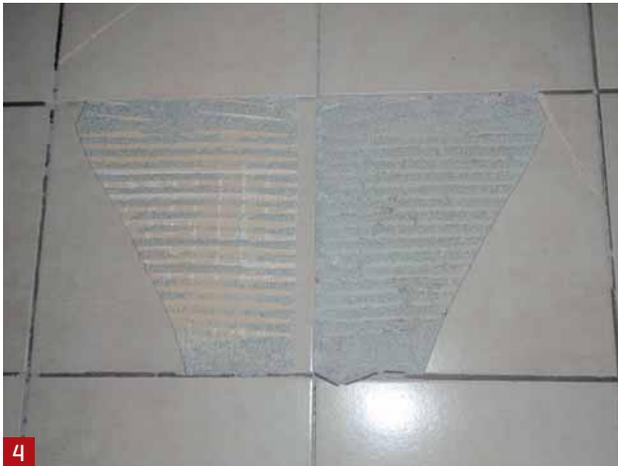
**IMAGE 4:** Poor contact coverage results in bond failure.

AS 3958.1 recommends 80% minimum contact coverage for internal main floor tiles, and 90% for external floor tiles and wet area wall tiling. This is achieved by ensuring a 3mm to 4mm finished adhesive bed thickness, with the required contact between the tile and substrate.

The correct sized trowel, back buttering of the tile and regular spot checks are essential. Anything less, either in contact coverage or finished adhesive thickness will drastically reduce tolerances to building movement.

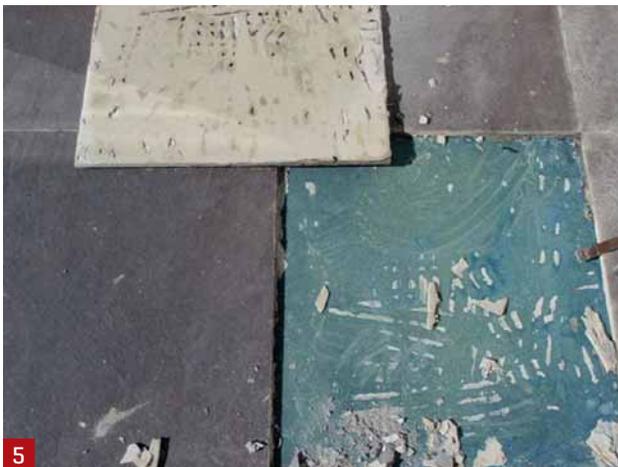
**IMAGE 5:** Functional failure, material not compatible.

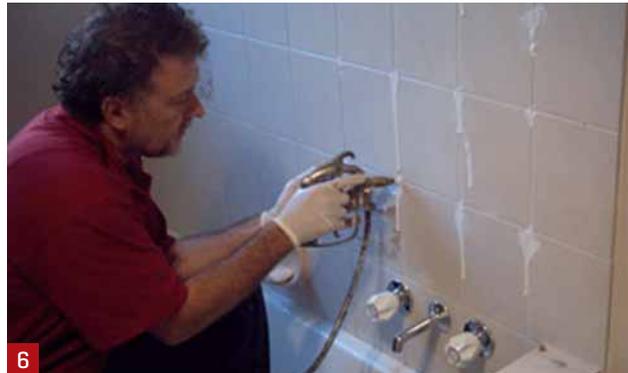
**IMAGE 6:** Reglue injection can be used to rebond tiles in situ.

Excessive deterioration can require full tiling replacement - especially when replacement tiles are no longer available. If it's identified early, this type of functional failure can be rectified using a tile reglue injection system, which will re-bond the tiles in situ without disturbing surrounding tiles. Only an approved system should be used, by licensed applicators, with the appropriate warranties. Tile reglue injection keeps cost and disruption times to a minimum and can usually be carried out while maintaining occupancy during repairs.

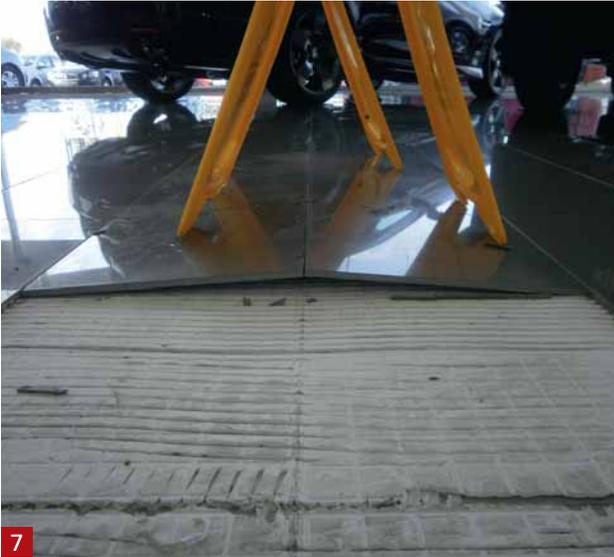
7

**IMAGE 7:** Peaked floor tiles. **IMAGE 8:** Poor contact coverage, skinned adhesive. **IMAGE 9:** Tile Reglue Injection Method being used on failed floor tiles.
